# TECHNICAL BULLETIN

## TRAILER SUSPENSION SYSTEMS HT250YS Y-BEAM SUSPENSION

**SUBJECT:** Recommended Inspection

**LIT NO:** T49001

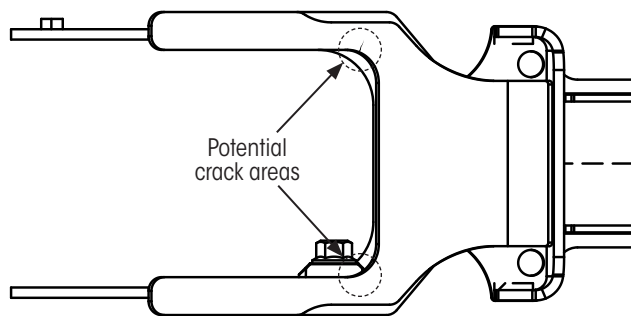
Hendrickson has become aware of a possible issue with certain HT250YS Y-beam suspensions. In a limited number of applications in the field, some HT250YS Y-beam suspensions have developed a crack in the yoke section of the suspension's trailing arm beam (Figure 1). In such circumstances, the initial crack will have negligible or no adverse effect on the performance of the axle or suspension. However, if this condition is allowed to progress over time, larger cracks could develop on the suspension beam yoke.

Figure 1: HT250YS Y-beam with crack forming (top view)

As a result, Hendrickson recommends all trailers equipped with HT250YS Y-beam suspensions be inspected for signs of cracking in the areas illustrated in Figure 1 (above) and Figure 2 on back page. This inspection can take place during the daily pre-trip inspection, during the trailer's periodic maintenance inspection inspections per Hendrickson literature number L578 *Preventive Maintenance Guide* or during unscheduled trailer maintenance.

If any cracks are observed, please contact Hendrickson Trailer Technical Services in the United States and Canada at 866-RIDEAIR (743-3247) or email [HTTS@Hendrickson-intl.com](mailto:HTTS@Hendrickson-intl.com) for information on how to proceed.

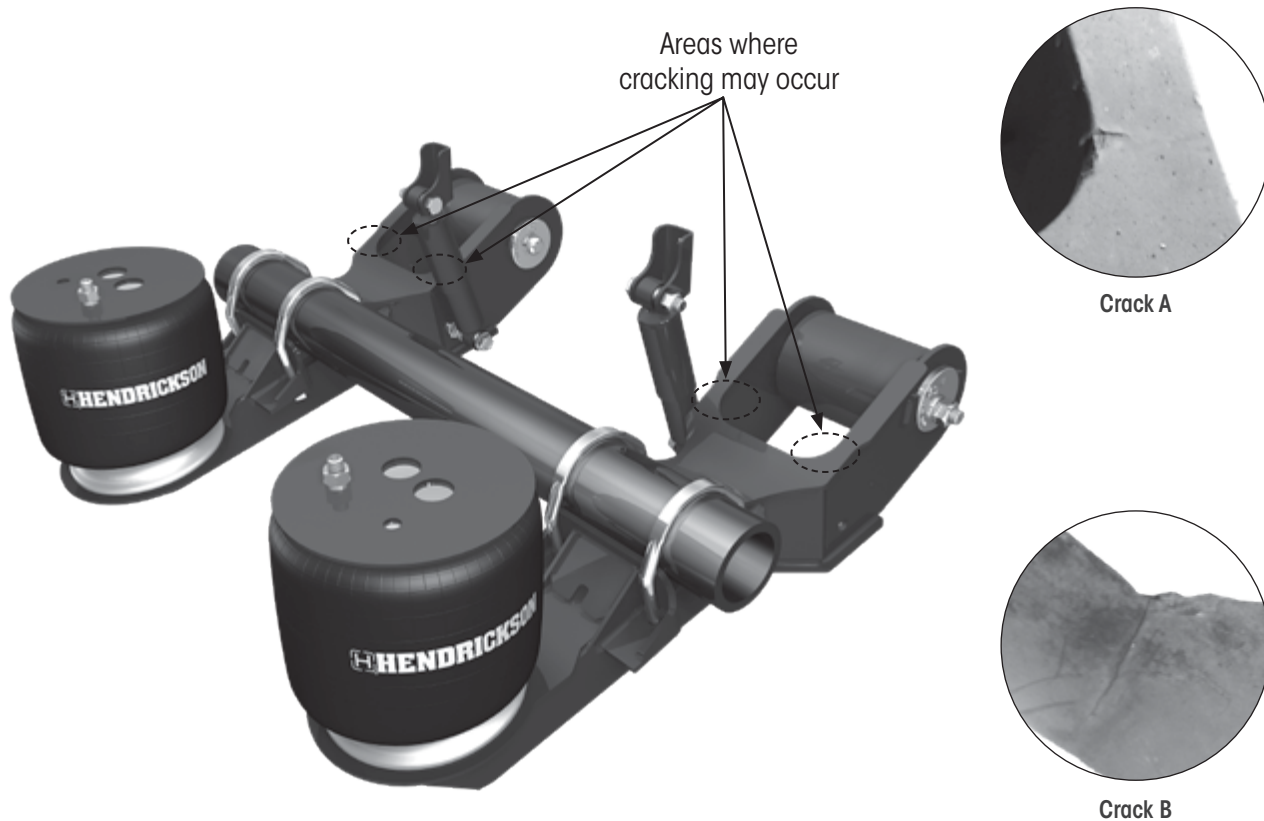
Figure 2: HT250YS Y-beam inspection areas

If a crack has progressed more than half way across the top plate (Figure 2 Crack B), the suspension should be immediately repaired, which will require a beam replacement. Contact Hendrickson as soon as possible.
