# TECHNICAL BULLETIN

## TRI-FUNCTIONAL® BUSHINGS

**SUBJECT:** Pivot Bushing Inspection Procedure

**LIT NO:** B106  
**DATE:** April 2018

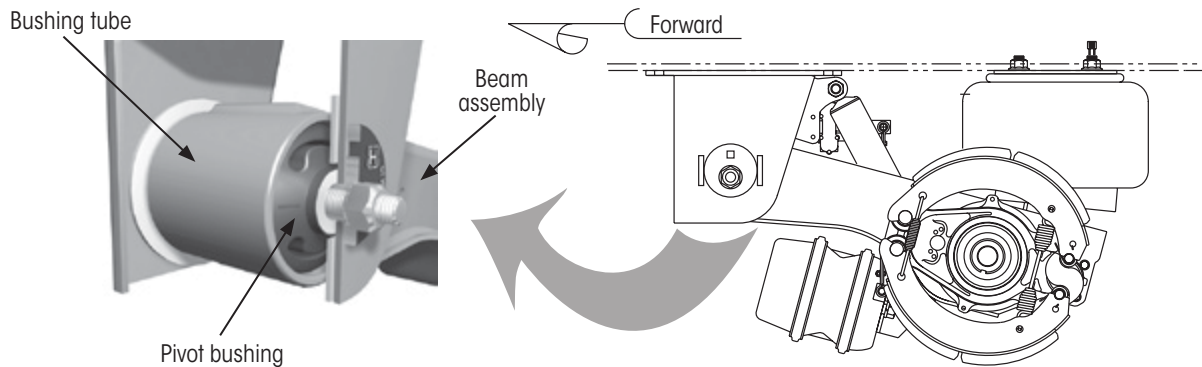
Figure 1: Pivot bushing components

Periodic inspections are an important part of the air suspension maintenance routine, L578 *Preventive Maintenance Guide*. Pivot bushings housed within the beam assembly bushing tube (Figure 1) are especially important. This publication is a useful guide to help determine the current functional condition of the pivot bushing. Depending on the age of the suspension, the used bushing may experience various states of fatigue that could include surface cracks or cracks forming between voids. However, the pivot bushing may still have many years of service life remaining. As a guide, this simple check can determine a bushing's current status.

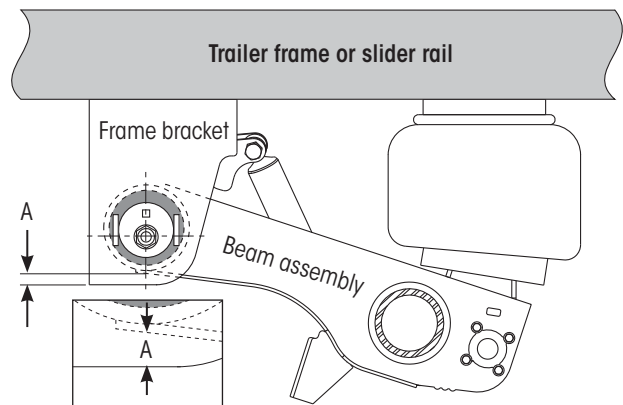
Figure 2: Pivot bushing measurement A (unloaded trailer recommended)

1. With the suspension at ride height, **measure** from the bottom of the beam assembly to the bottom of the frame bracket (Figure 2).

2. If measurement **A** is less than or equal to the specified value in Table 1, the bushing is performing as expected.

If measurement **A** is greater than the specified value in Table 1, the pivot connection must be disassembled and the beam assembly lowered to more closely inspect the bushing. Reference Figure 3 on next page.

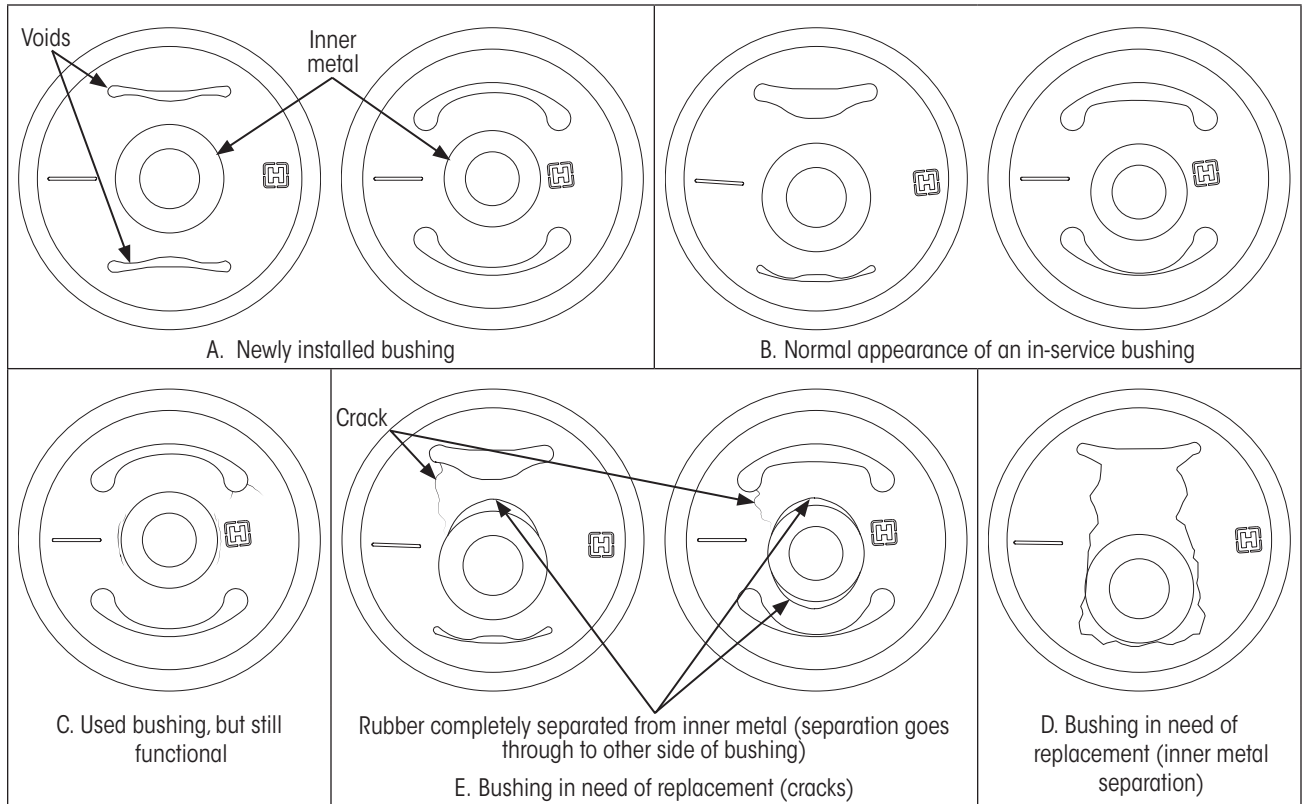
Figure 3: Bushing evaluation guide

Pivot bushings will typically “settle” in the vertical direction upon suspension installation (Figure 3, A). It is normal for the voids to have this “settled” appearance (Figure 3, B and C) due to cargo and the weight of the trailer loading the bushing. However, cracks in the rubber extending between the void and the bushing’s inner metal or an excessive amount of vertical movement (Figure 3, E and D) are indications the bushing needs to be replaced.

The appearance of smeared blackened rubber or hanging strands of rubber around the bushing tube edges, bushing tube spacer(s), etc. is an indication the bushing is heating up and melting. The cause is likely continuous rapid vibration induced into the bushing through the beam. It is usually caused by an imbalanced wheel-end on the same side as the affected bushing. A wheel-end can be out of balance due to one or more of the following: issues with the tire(s), improper assembly, dropped or out-of-round drum, mud or debris collected on the rim, water in the tire, non-functioning shock absorber and more.

Refer to Hendrickson literature number *L427 Bushing Replacement Procedures* for bushing replacement instructions. Hendrickson literature number *L427* and *L750 Bushing Tube Spacer Inspection and Replacement Procedure* include procedures to inspect bushing tube and frame bracket for wear.
