H TECHNICAL PROCEDURE

TRAILER SUSPENSION SYSTEMS

SUBJECT: QUIK-ALIGN® Pivot Connection
Fastener Upgrade

LIT NO: B92
DATE: May 2014

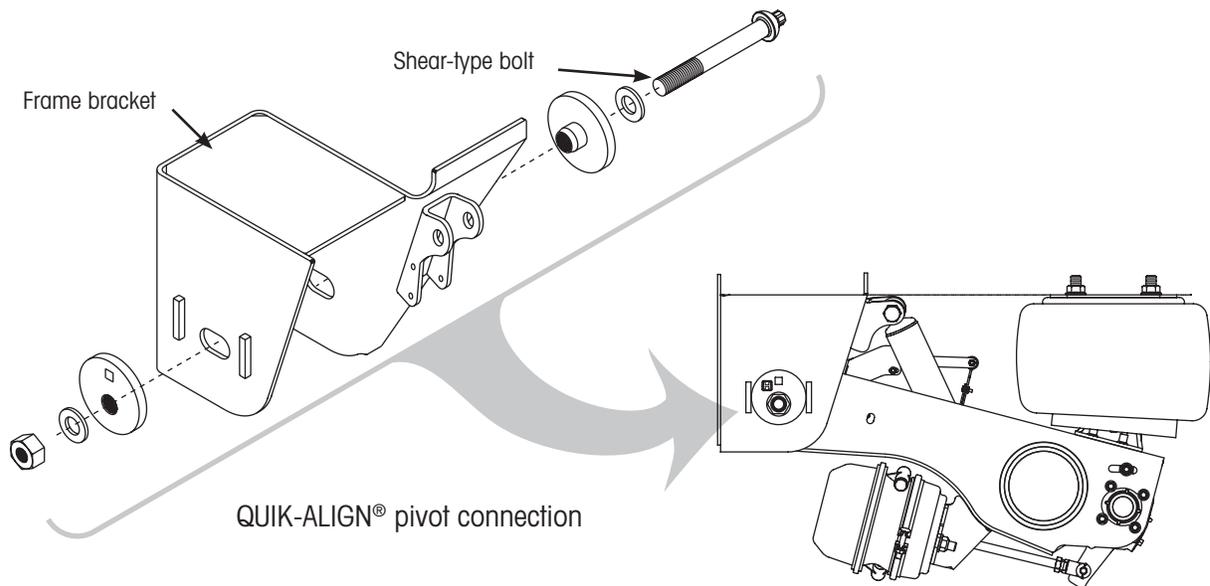
In keeping with our philosophy of continuous improvement, Hendrickson Trailer Suspension Systems will implement a revision to all suspension models and aftermarket kits equipped with the QUIK-ALIGN® pivot connection. A round-head shear type bolt will replace the previous hex-head shear-type bolt to help make the connection tamper resistant.

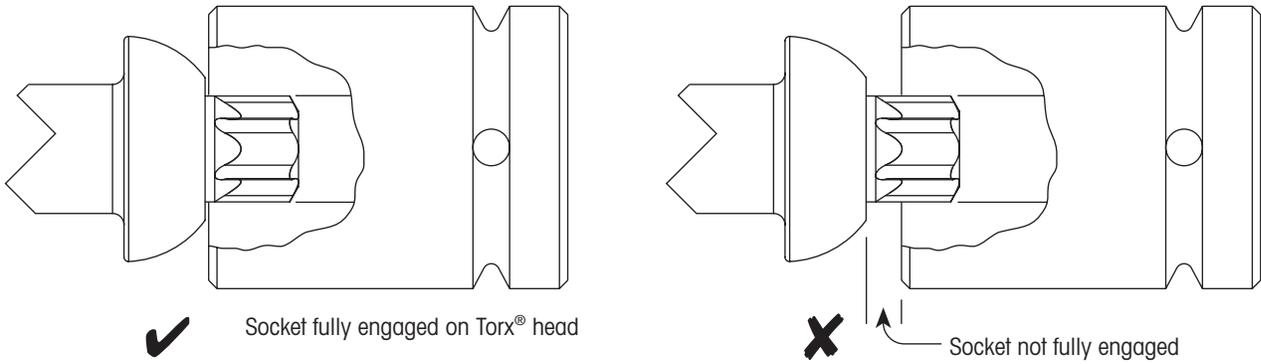
Hendrickson does not recommend the 3/4-in. drive socket for use in high volume trailer production environments. The 3/4-in. drive socket can back away from full Torx® head engagement during the shearing process and strip the Torx-head splines. When damage occurs to the Torx-head splines, the proper torque and clamp force may not be achieved.

For high volume trailer production and service facilities, Hendrickson recommends the one-inch drive E20 Torx® socket with sleeve (part number A-25119). The sleeve helps support the tool by riding over the entire head of the shear bolt. It also provides greater operator control at the moment of shear by preventing the heavy tool from veering. The operator can rest the tool against the collar during the entire operation resulting in full socket-to-bolt engagement, reduced fatigue and consistent, properly torqued pivot connections.
