TECHNICAL BULLETIN

HT LOWER SHOCK BRACKET REPAIR

LIT NO: 97117-177

REVISION: E

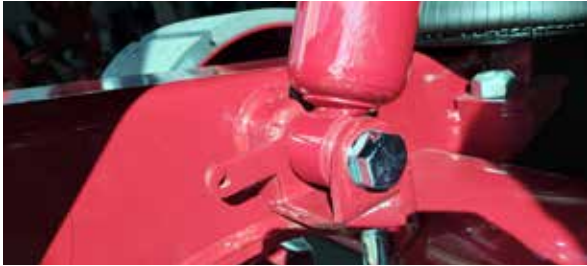
Figure 1: Lower Shock Support & Clevis

This restoration procedure is to repair instances of a cracked weld around the trailing arm shock absorber bracket of HT Top Mount suspensions. The clevis can be effectively replaced if the lower shock absorber clevis becomes detached or a crack is detected at the connection to the trailing arm. Refer [Figure 1](#).

The Hendrickson repair kit contains a replacement clevis, shock absorber bolt and reinforcement gusset block. Where the weld retaining the original clevis has cracked, or the clevis has become detached, grind off the remaining weld. It is essential that cracks or damage to the trailing arm plate are ground, repair welded, and the area is smooth and flat prior to the new clevis being fitted.
