# TECHNICAL BULLETIN

## TRI-FUNCTIONAL® BUSHINGS

**SUBJECT:** Pivot Bushing Inspection Procedure

**LIT NO:** B106

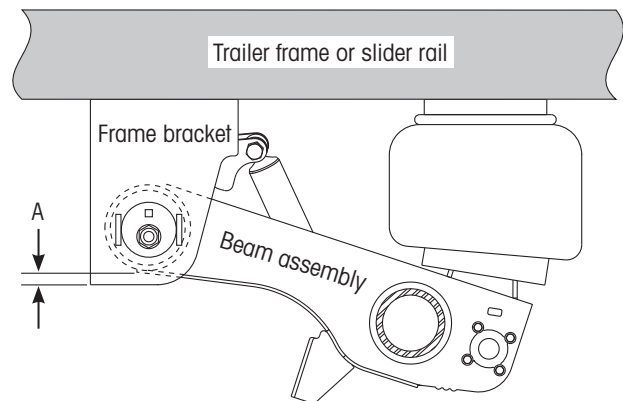
Hendrickson does not recommend disassembling the pivot connection to inspect the pivot bushing. The recommended procedure is to make a measurement as follows. On an unloaded trailer, measure from the bottom of the beam assembly to the bottom of the frame bracket as shown below.

SUSPENSION TYPE	A	
	Inch	mm
ULTRAA-K	1 1/8	28.5
HT, INTRAAX & VANTRAAX	3/4	19

If **A** is less than or equal to the above specified value: the bushing is **OK**.

If **A** is greater than the above specified value: the pivot connection must be disassembled and the beam assembly lowered to more closely inspect the bushing. Refer to [Figure 1](#) on next page.

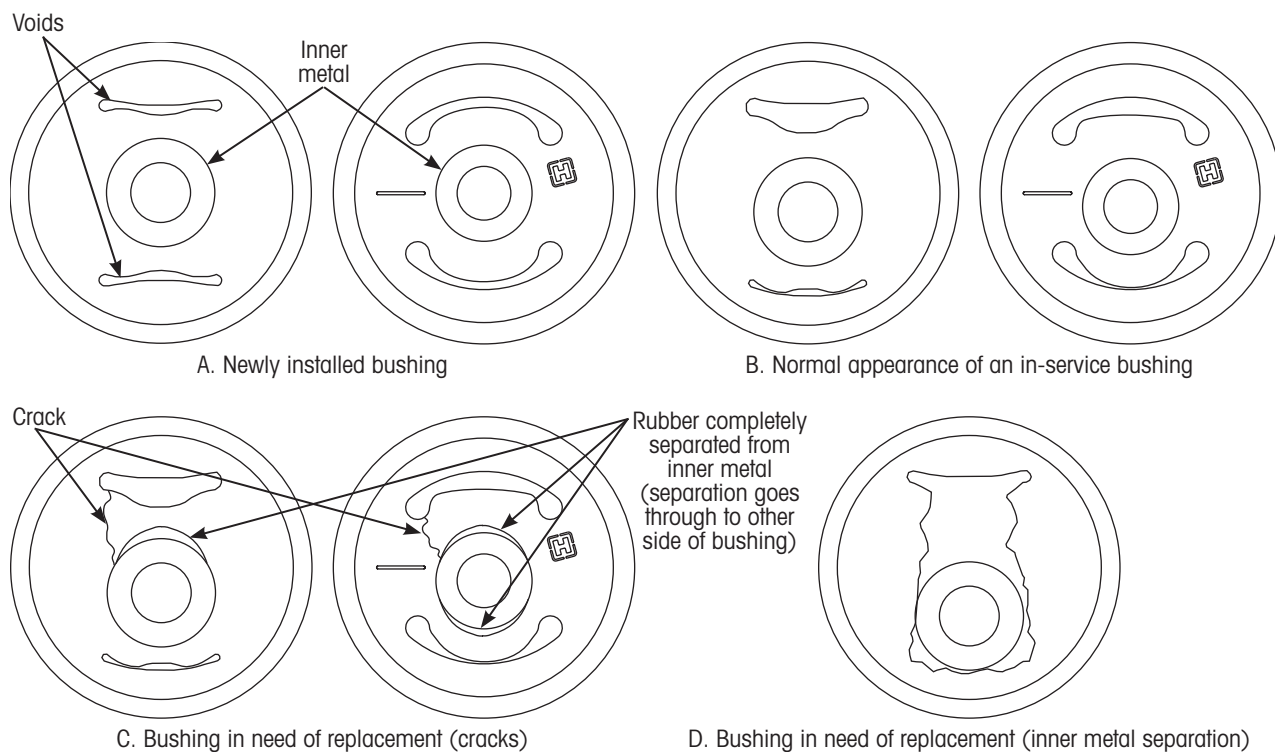
Figure 1: *Bushing evaluation guide*

Pivot bushings will typically “settle” in the vertical direction upon suspension installation. It is normal for the voids to have this “settled” appearance (illustration B) due to cargo and the weight of the trailer loading the bushing. However, cracks in the rubber extending between the void and the bushing’s inner metal or an excessive amount of vertical movement (illustrations C and D) are indications that the bushing needs to be replaced. If conditions similar to C and D are found, replace the bushing. For warranty consideration, per [L583 Comprehensive Warranty Statement, Required Claim Information](#); include **a digital photograph of the bushing in the bushing tube** for preliminary review and send out replacement parts. The photo must be taken before removing the bushing from the bushing tube. The removed bushings will need to be returned to Hendrickson for further review and also consideration for labor reimbursement, if applicable.

Refer to Hendrickson literature number [L427 Bushing Replacement Procedures](#) for bushing replacement instructions. Also at this time inspect the bushing tube and interior surfaces of the frame bracket for wear. Refer to Hendrickson literature number [L750 Bushing Tube Spacer Inspection / Replacement Procedure](#) for bushing tube and frame bracket inspection / replacement instructions.
