## H TECHNICAL PROCEDURE PIVOT BUSHINGS

SUBJECT: Bushing Tube Spacer Inspection / Replacement Procedure

LIT NO: L750 DATE: August 2023

**REVISION:** E

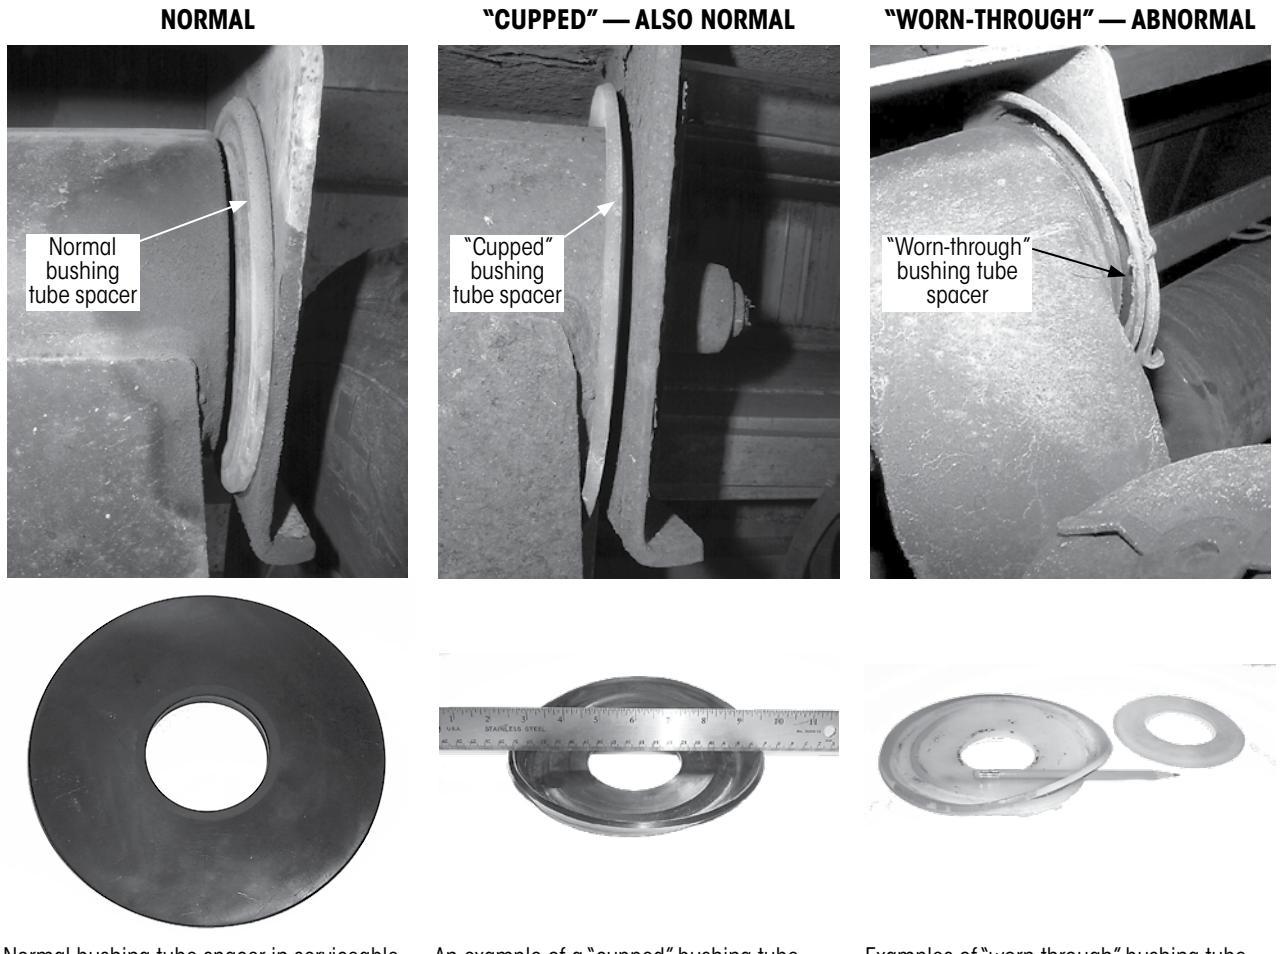
Figure 2: *Bushing tube spacer examples*

Normal bushing tube spacer in serviceable condition.

An example of a "cupped" bushing tube spacer. Friction-generated heat causes the spacer to "form" or "cup" around the bushing and bushing tube. This is normal and serviceable as long as the bushing tube spacer remains intact and does not become cut or worn-through.

Examples of "worn-through" bushing tube spacers. The spacer on the right is an example of extreme wear. Its circumference has been completely trimmed by the bushing tube. The spacer is not in serviceable condition.

Visually verify that the bushing tube spacers are intact and are not missing, cut, worn-through or otherwise deteriorated. Due to the pivoting motion inherent with this connection, some bushing tube spacer wear is expected (Figure 2). Bushing tube spacer "cupping", where the bushing tube spacer forms around the bushing tube and resembles a shallow dish, is also normal. If you see these conditions, no further inspection is required at this time. The bushing tube spacers are in serviceable condition.

However, a bushing tube spacer that is completely missing, has been cut or worn through is considered abnormal. If these conditions exist, a closer, more detailed inspection is required to prevent serious or costly problems and to prolong the life of the suspension.

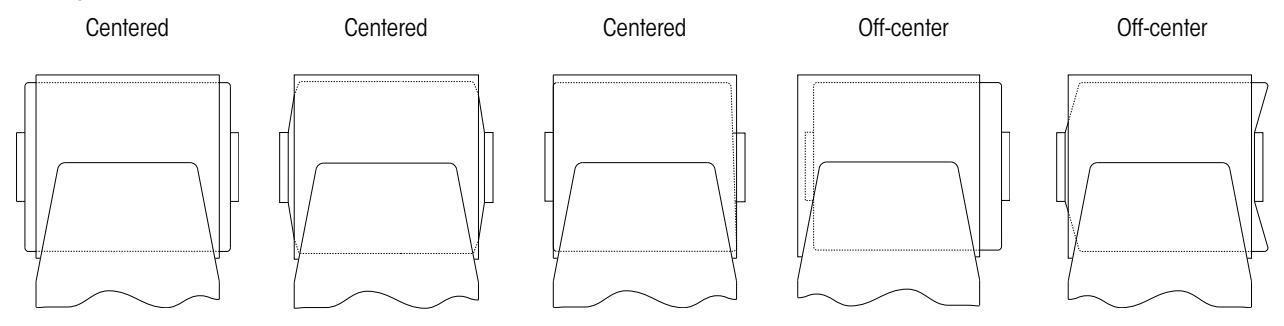
Figure 3: Examples of bushing position relative to the bushing tube (not representative of every possible case).

For evaluation purposes, the pivot bushing is considered either centered or off-center with respect to the bushing tube (<u>Figure 3</u>). The pivot bushing is considered off-center when a portion of the rubber extends outside of the bushing tube on one side and not on the other.

The key to identifying an off-center bushing is the bushing tube spacers. If the bushing tube spacers are in serviceable condition (not missing, cut, worn-through or otherwise deteriorated), the bushing cannot be off-center (Figure 3).

**NOTE:** DO NOT attempt to center an off-center bushing. Remove the off-centered bushing and install new bushings per axle.

If the bushing is off-center, but the bushing tube width is acceptable (<u>Table 2 on page 6</u>), replace the bushing. Refer to Hendrickson literature number <u>L427</u> *Bushing Replacement Procedure* for complete bushing replacement instructions.

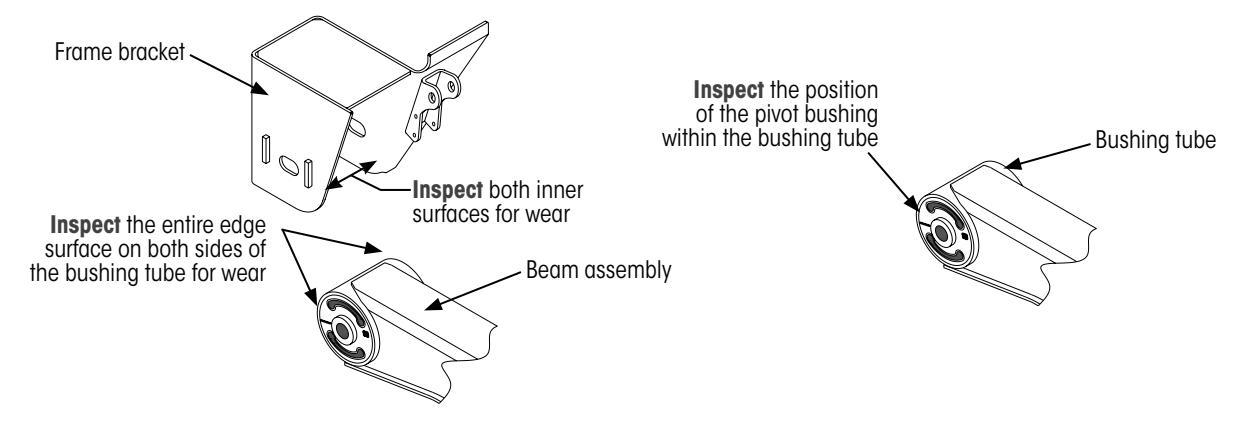
Figure 4: *Pivot connection component inspection*

If a missing, cut or otherwise worn through bushing tube spacer is discovered, the suspension pivot connection must be disassembled and the beam assembly lowered to check for potential beam and/or frame bracket wear (Figure 4). Refer to Hendrickson literature number L427 *Bushing Replacement Procedure* for complete pivot connection disassembly instructions.

With the beam assembly lowered (Figure 4 on page 4), inspect inner surfaces of the frame bracket and edges of the bushing tube for wear. Also inspect the position of the pivot bushing within the bushing tube. The condition of these three areas will dictate the repair requirements or the necessity to replace any parts as instructed in Table 2 on page 6.

With the beam assembly lowered (Figure 4 on page 4), inspect the inner surfaces of the frame bracket. Some wear (polished metal) on the inner surface of the frame bracket is considered normal due to the pivoting motion inherent with this connection. Gouges or grooves worn into the frame bracket are abnormal. If any gouges, grooves or missing metal is found, the frame bracket must be replaced. For complete frame bracket replacement instructions, refer to applicable Hendrickson literature listed at the top of page 2.

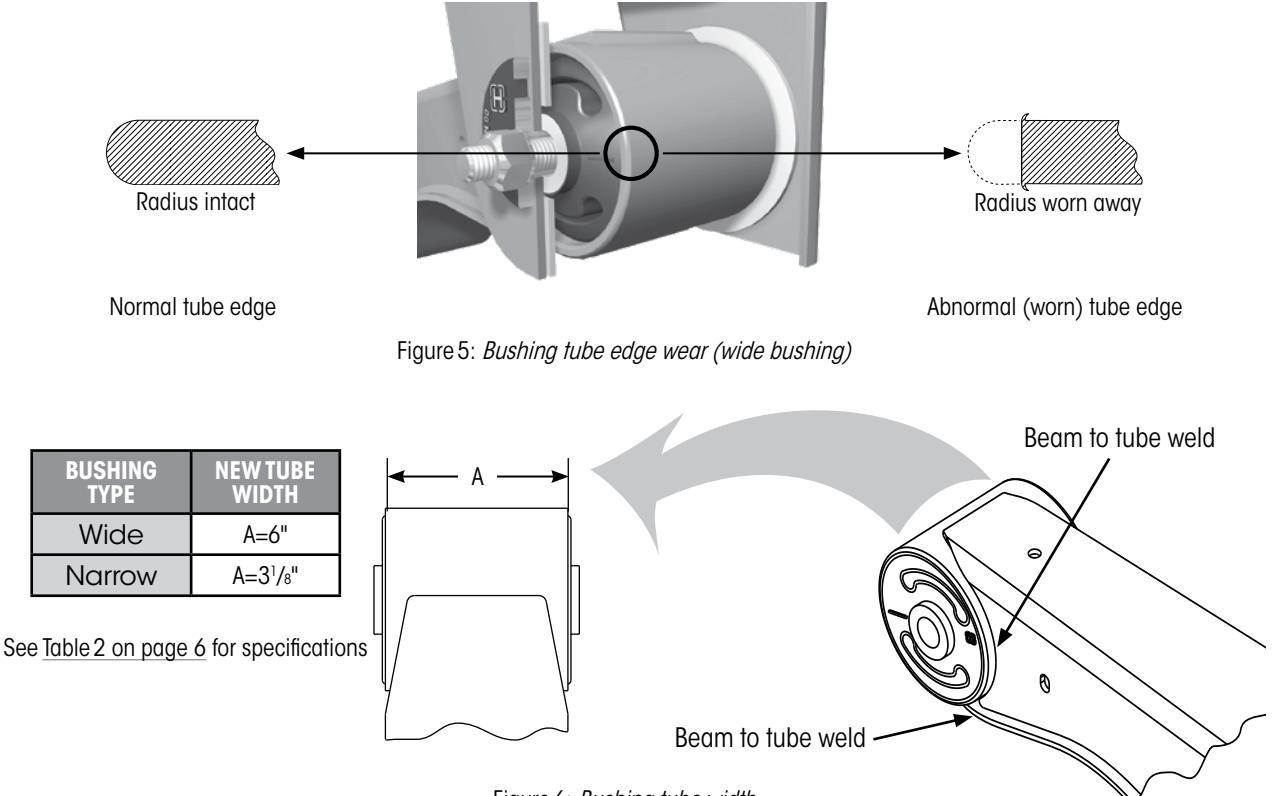
Figure 6: Bushing tube width

Some wear (polished metal) on the edge of the bushing tube is considered normal (<u>Figure 5</u>) due to the pivoting motion inherent with this connection. Missing metal where the bushing tube's radius edge has been worn away is considered abnormal. If this type of wear is present, refer to <u>Table 2 on page 6</u>.

Refer to the <u>REPAIR RECOMMENDATIONS on page 6</u> for repair procedures based on bushing tube width.

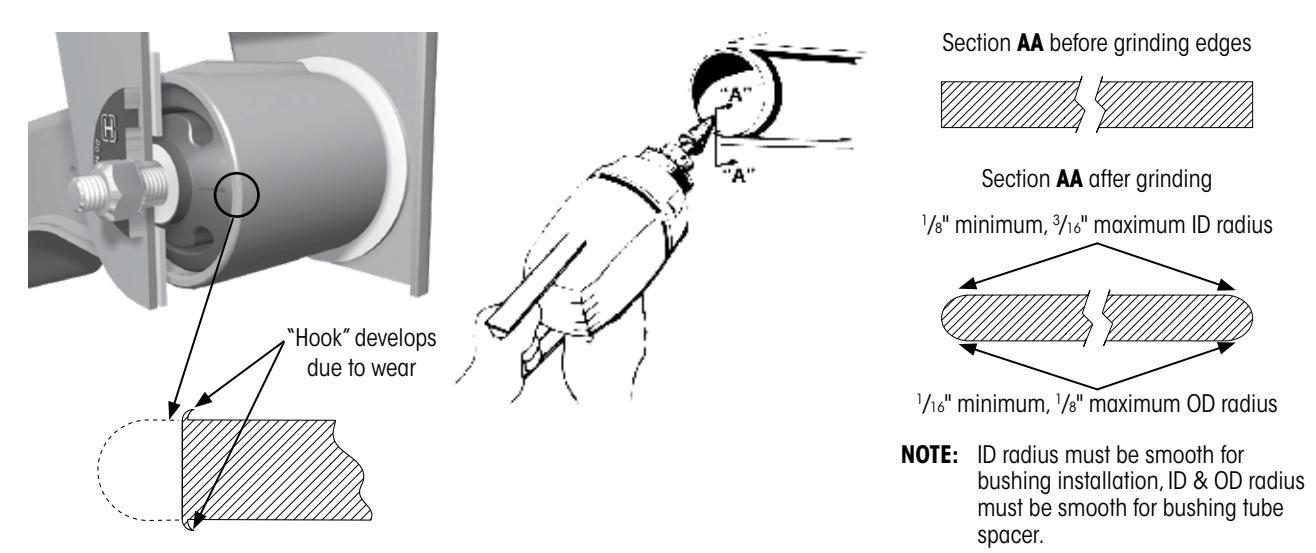
Figure 7: Repairing bushing tube edge

When the bushing tube wears, a slight "hook" or "tooth" of metal may develop on both inside and outside diameters of the tube (Figure 7). As the vehicle turns, the unique design of the pivot bushing allows it to elongate sightly to absorb the forces associated with road surface, load, etc. When the turn is complete and those particular forces are no longer present, the pivot bushing returns to its original position. If the "hook" or "tooth" on the bushing tube is not removed, it can "bite" into the rubber pivot bushing when elongated and hold or prevent it from returning to its original position, which is unacceptable. As this is repeated, the pivot bushing can eventually be pulled out of the bushing tube. The rubber pivot bushing may also become damaged by these irregular edges.

As described in <u>Table 2 on page 6</u>, it is acceptable to reuse the bushing tube if within the specifications listed in the table. However, the bushing tube edge must be dressed before the new bushing is installed. If not properly dressed, bushing tube and frame bracket components will wear more rapidly than normal.

Before attempting to install a new bushing, the worn bushing tube edge must be dressed. Use a grinder to re-establish a radius on the edge of the bushing tube as shown in Figure 7 on page 7 and defined in Table 2.
