H TECHNICAL BULLETIN

TRI-FUNCTIONAL® BUSHINGS

SUBJECT: Pivot Bushing Inspection Procedure

LIT NO: B106

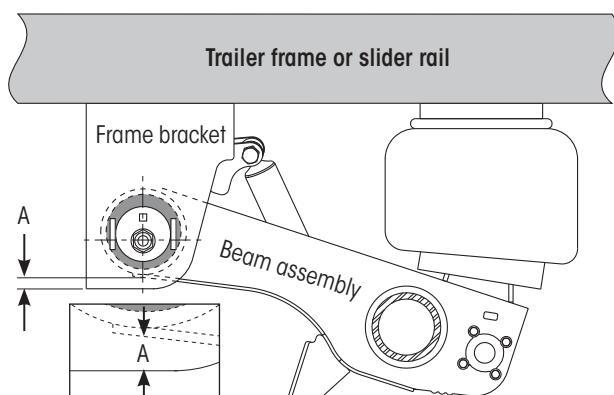
Figure 2: Pivot bushing measurement A (unloaded trailer recommended)

1. With the suspension at ride height, **measure** from the bottom of the beam assembly to the bottom of the frame bracket (Figure 2).

2. If measurement **A** is less than or equal to the specified value in Table 1, the bushing is performing as expected.

If measurement **A** is greater than the specified value in Table 1, the pivot connection must be disassembled and the beam assembly lowered to more closely inspect the bushing. Reference Figure 3 on next page.

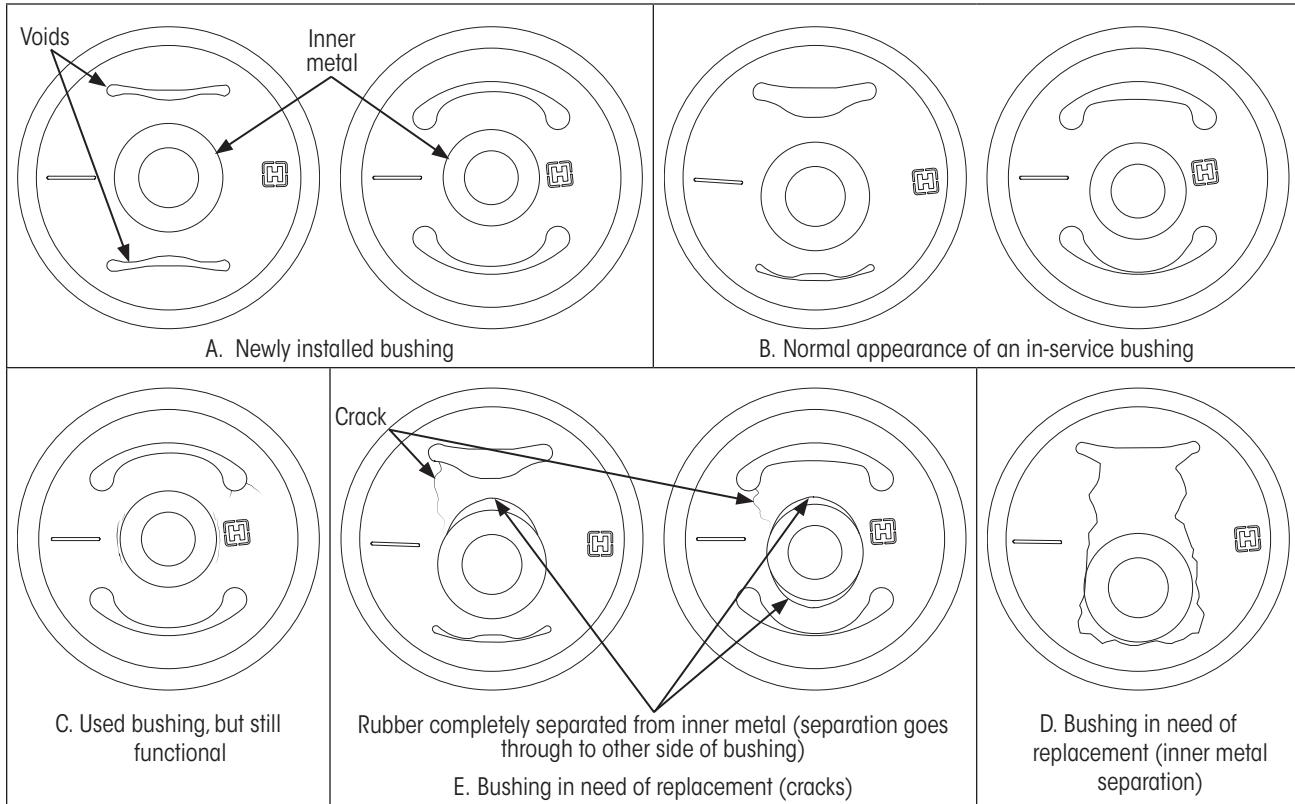
Figure 3: Bushing evaluation guide

Pivot bushings will typically "settle" in the vertical direction upon suspension installation (Figure 3, A). It is normal for the voids to have this "settled" appearance (Figure 3, B and C) due to cargo and the weight of the trailer loading the bushing. However, cracks in the rubber extending between the void and the bushing's inner metal or an excessive amount of vertical movement (Figure 3, E and D) are indications the bushing needs to be replaced.

The appearance of smeared blackened rubber or hanging strands of rubber around the bushing tube edges, bushing tube spacer(s), etc. is an indication the bushing is heating up and melting. The cause is likely continuous rapid vibration induced into the bushing through the beam. It is usually caused by an imbalanced wheel-end on the same side as the affected bushing. A wheel-end can be out of balance due to one or more of the following: issues with the tire(s), improper assembly, dropped or out-of-round drum, mud or debris collected on the rim, water in the tire, non-functioning shock absorber and more.

Refer to Hendrickson literature number L427 Bushing Replacement Procedures for bushing replacement instructions. Hendrickson literature number L427 and L750 Bushing Tube Spacer Inspection and Replacement Procedure include procedures to inspect bushing tube and frame bracket for wear.
