# **H** TECHNICAL PROCEDURE

## TRI-FUNCTIONAL<sup>®</sup> BUSHINGS

**SUBJECT:** Replacement Bushing Tube Spacer  
Orientation

**LIT NO:** L893

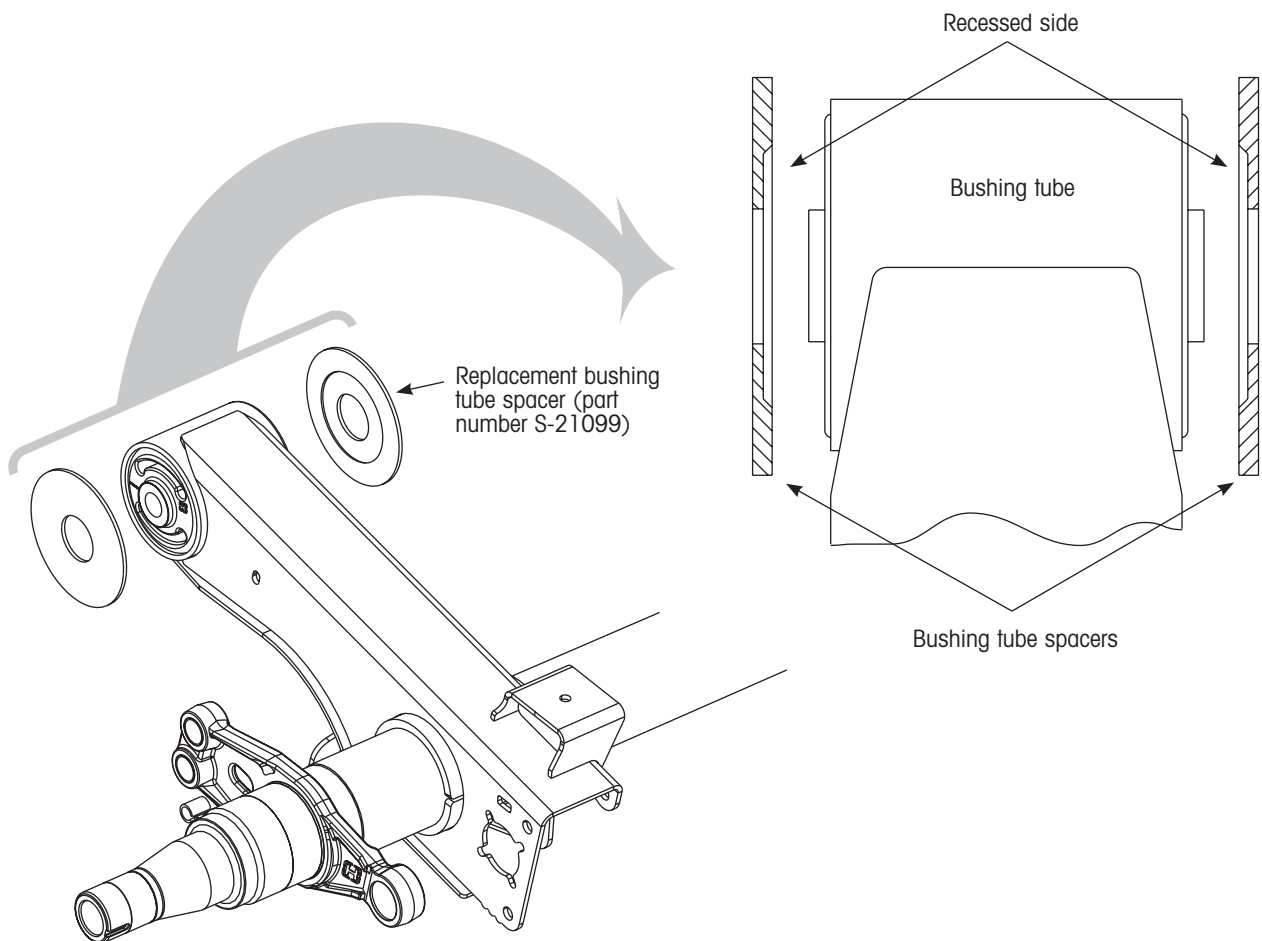
When installing the replacement bushing tube spacers in this kit, make sure the recessed side of each spacer faces the bushing tube as shown in figure 1.

Figure 1. Properly orienting the replacement bushing tube spacer for installation

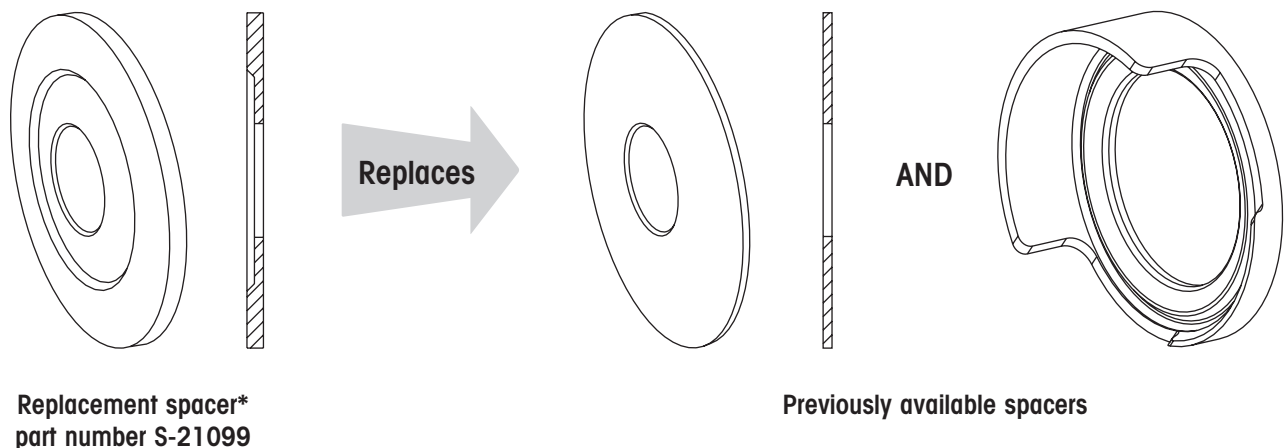
Available individually or in a kit, the replacement BTS supercedes both previously-available spacers: the flat spacer, part number S-11613, and the cap-style spacer (see illustration below). The replacement BTS is also being included in all bushing service kits, such as S-6914 and S-24691.

\*Note: Machined recess on S-21099 spacer must face towards the exposed surface of the bushing.
