# TECHNICAL BULLETIN

## TRI-FUNCTIONAL® BUSHINGS

**SUBJECT:** Pivot Bushing Inspection Procedure

**LIT NO:** B106

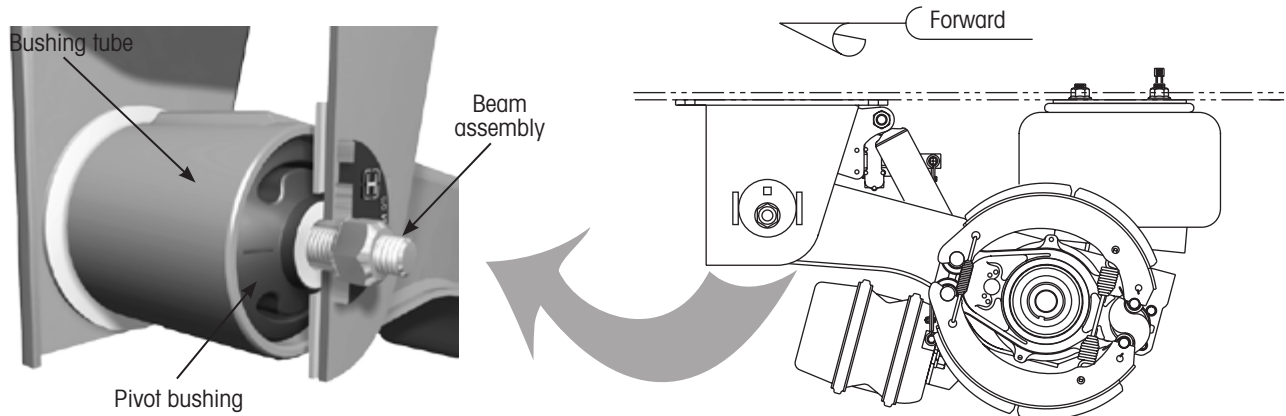
Hendrickson does not recommend disassembling the pivot connection to inspect the pivot bushing. The recommended procedure is to make a measurement as follows. On an unloaded trailer, measure from the bottom of the beam assembly to the bottom of the frame bracket as shown below.

**NOTE:** Trailer must be unloaded.

SUSPENSION TYPE	A	
	Inch	mm
ULTRAA-K	1 1/8	28.5
HT, INTRAAX & VANTRAAX	3/4	19

If **A** is less than or equal to the above specified value: the bushing is **OK**.

If **A** is greater than the above specified value: the pivot connection must be disassembled and the beam assembly lowered to more closely inspect the bushing. Refer to [Figure 1](#) on next page.
