## H TECHNICAL PROCEDURE PIVOT BUSHINGS

SUBJECT: Bushing Tube Spacer Inspection / Replacement Procedure

LIT NO: L750 DATE: August 2023

**REVISION:** E

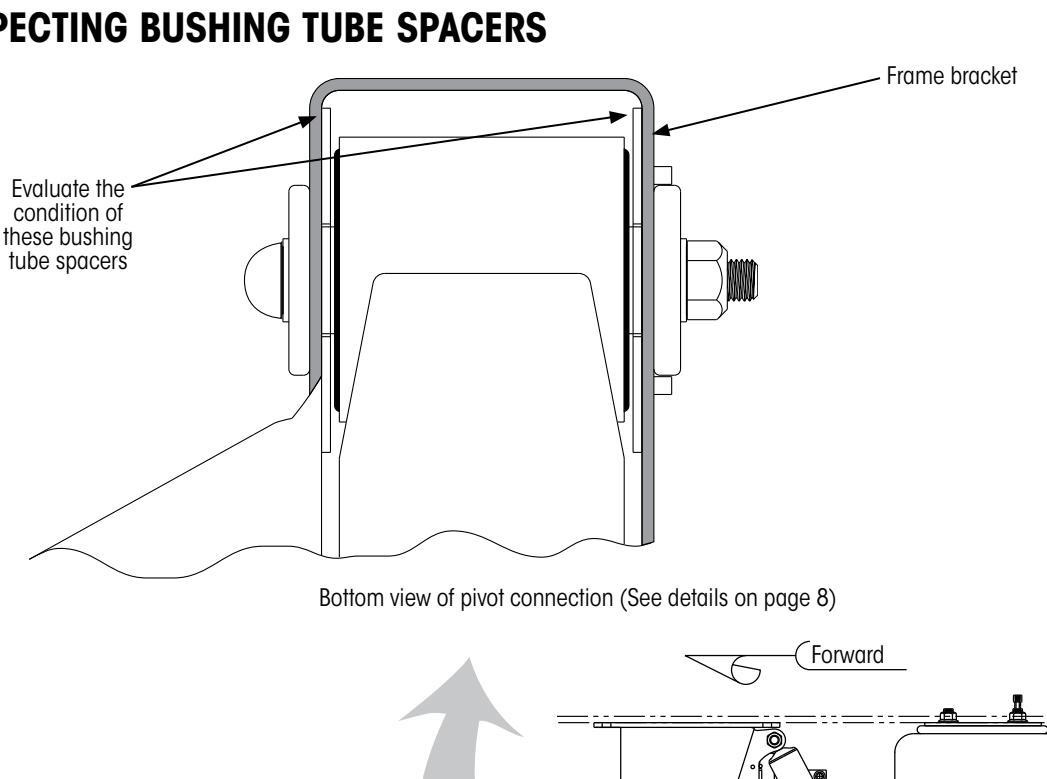
Table 1: Bushing types

The bushing tube (shown on front cover) evaluation information in this document applies to both wide and narrow bushing types (Table 1).
