H TECHNICAL BULLETIN

TRI-FUNCTIONAL® BUSHINGS

SUBJECT: Pivot Bushing Inspection Procedure

LIT NO: B106

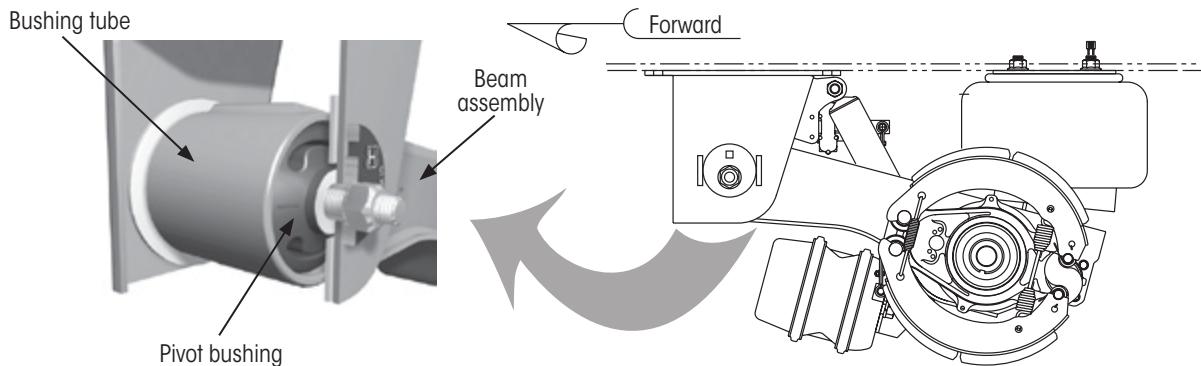
Figure 1: Pivot bushing components

Periodic inspections are an important part of the air suspension maintenance routine, *L578 Preventive Maintenance Guide*. Pivot bushings housed within the beam assembly bushing tube (Figure 1) are especially important. This publication is a useful guide to help determine the current functional condition of the pivot bushing. Depending on the age of the suspension, the used bushing may experience various states of fatigue that could include surface cracks or cracks forming between voids. However, the pivot bushing may still have many years of service life remaining. As a guide, this simple check can determine a bushing's current status.
