H TECHNICAL PROCEDURE

TRAILER SUSPENSION SYSTEMS

SUBJECT: QUIK-ALIGN® Pivot Connection
Fastener Upgrade

LIT NO: B92
DATE: May 2014

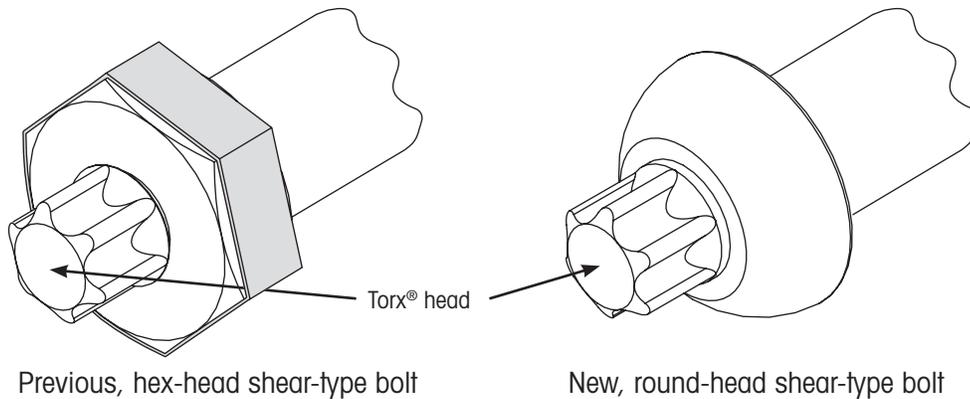
The shear-type bolt is well known to Hendrickson customers as a fast, flexible and convenient way to apply the proper torque and clamp force at the pivot connection. Simply install the bolt from the inboard side of the frame bracket and tighten with an E20 Torx® socket until the bolt's Torx® head shears off. That feature has not changed. The new shear-type bolt functions exactly the same as the previous design.

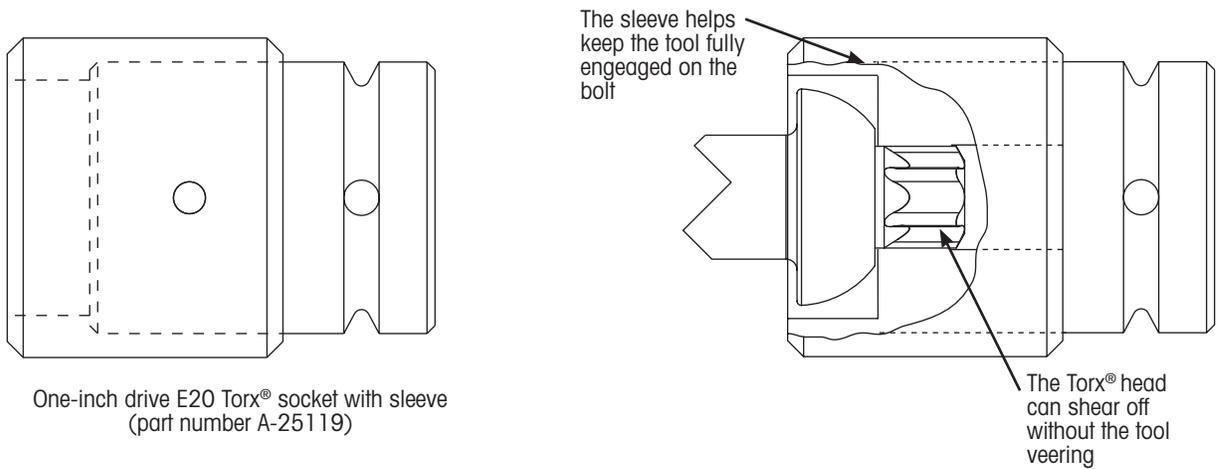
Hendrickson does not recommend the 3/4-in. drive socket for use in high volume trailer production environments. The 3/4-in. drive socket can back away from full Torx® head engagement during the shearing process and strip the Torx-head splines. When damage occurs to the Torx-head splines, the proper torque and clamp force may not be achieved.

For high volume trailer production and service facilities, Hendrickson recommends the one-inch drive E20 Torx® socket with sleeve (part number A-25119). The sleeve helps support the tool by riding over the entire head of the shear bolt. It also provides greater operator control at the moment of shear by preventing the heavy tool from veering. The operator can rest the tool against the collar during the entire operation resulting in full socket-to-bolt engagement, reduced fatigue and consistent, properly torqued pivot connections.
