TECHNICAL PROCEDURE

TRAILER SUSPENSION SYSTEMS AKAD0012 LIFT AXLE VALVE

SUBJECT: Test Procedure

LIT NO: T52002

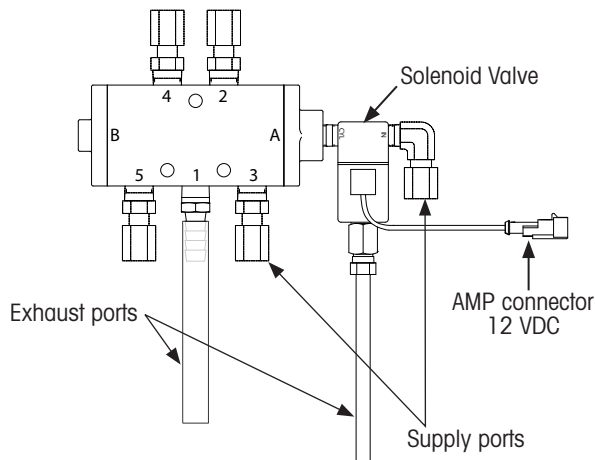
Figure 1: AKAD0012 lift valve assembly

- B. AKAD0012 **valve orientation** is as shown in Figure 1, Figure 2 and Figure 3 with the exhaust ports pointing downward.
- C. Exhaust ports **exhaust freely**, tubes are present and from 4 - 6 inches in length.
- D. AKAD0012 **wires/connector** are not corroded, broken or shorted.
- E. The AKAD0012 **solenoid CYL port is facing the valve** (Figure 1).
