SECTION 7

Preventive Maintenance

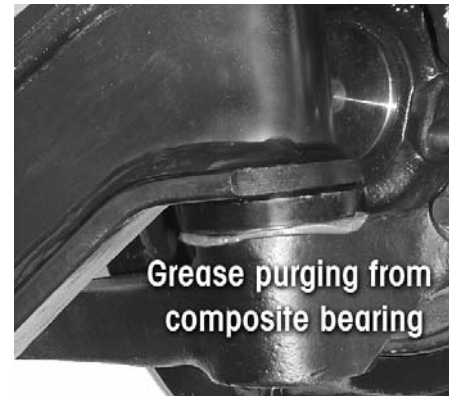
FIGURE 7-4

1. Place vehicle on the ground.
2. Prior to greasing the king pins on the vehicle, the suspension must be in a loaded condition.
3. Clean off all the grease fittings with a clean shop towel prior to lubrication.
4. Lubricate the king pins through the grease fittings on the top and bottom of the steering knuckle, see Lubrication Specification matrix above.
5. Force the required lubricant into the upper and lower king pin grease fittings, until new lubricant flows from grease purging locations, see Figure 7-4 and 7-6.
 - Upper axle beam and knuckle.
 - Thrust bearing purge locations (See Figure 7-5 and 7-6).

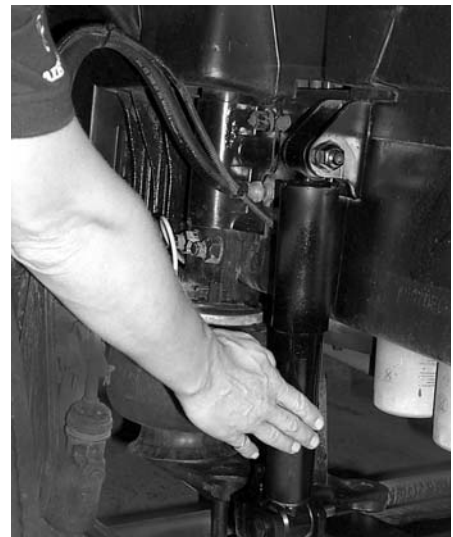
FIGURE 7-14

Hendrickson uses a long service life, premium shock absorber on all AIRTEK suspensions. When the shock absorber replacement is necessary, Hendrickson recommends that the shock absorbers be replaced with identical

Inspection of the shock absorber can be performed by doing a heat test, and a visual inspection. For instructions on shock absorber replacement see the Component Replacement Section of this publication. It is not necessary to replace shock absorbers in pairs if one shock absorber requires replacement.

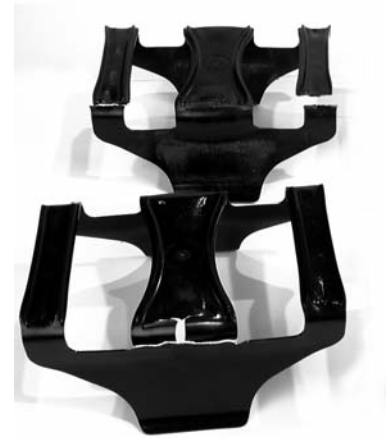
FIGURE 7-17

It is possible for the axle wrap liner to crack during service. If the liner is cracked and all the pieces are intact it is not necessary to replace the liner. If the liner is broken out and there are pieces missing the liner must be replaced immediately. See Figure 7-17. See Axle Wrap replacement in the Component Replacement Section of this publication.

**Axle Wrap Liners
Unacceptable Cracks**

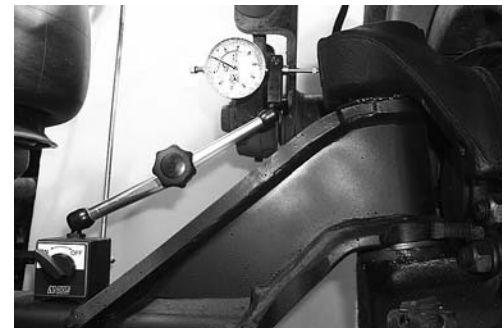
FIGURE 7-18

3. Checking the upper king pin bushing. Install the base of a dial indicator onto the axle beam. See Figure 7-18.

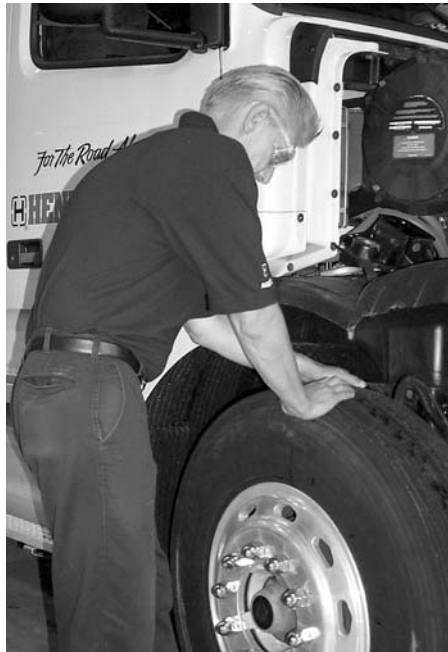
FIGURE 7-19

5. Move the top of the tire in and out by applying reasonable constant pressure and then release, see Figure 7-19.

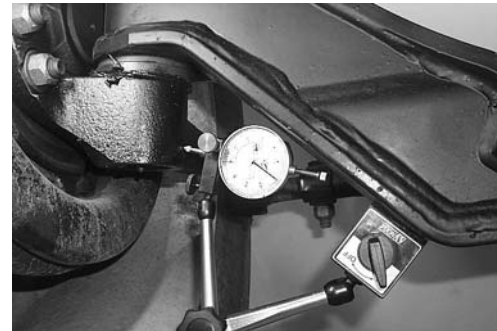
FIGURE 7-20

7. **CHECKING THE LOWER KING PIN BUSHING.** Install a dial indicator so that the base is on the axle and the indicator tip is against the inside of the bottom of the knuckle. See Figure 7-20.

9. Move the bottom of the tire in and out. If the dial indicator moves more than 0.015", the lower bushing is worn or damaged. Replace both king pin bushings. Refer to the Component Replacement Section of this publication.
