ASSEMBLY INSTRUCTIONS

PRIMAAX® 230/460/690

SUBJECT: Severe Service Kit No. 58821-026

This publication is intended to assist maintenance personnel with the installation of the Severe Service Top Pad Bolt Kit No. 58821-026 for **PRIMAAX 230/460/690** rear air suspensions.

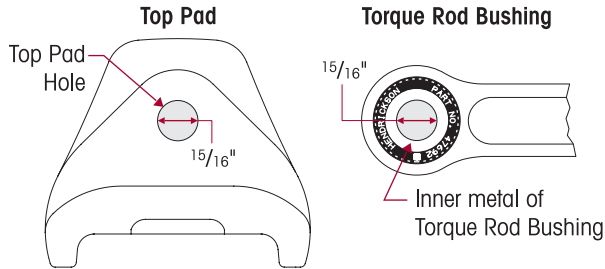
FIGURE 1

NOTE: The new M24 bolt should pass through the top pad hole and the inner metal of the torque rod bushing.

Prior to assembly, verify the new M24 bolt will pass through the existing top pad and inner metal of the torque rod bushing. See Figure 1.

1. Verify the new M24 bolt will pass through the existing top pad and inner metal of the torque rod bushing. If the fastener will not pass through the part(s), enlarge the hole(s) to $\frac{15}{16}$ " (0.937"). See Figure 1. To access top pad hole, clamp group disassembly may be required. Refer to Hendrickson publication 17730-238 for proper clamp group service instructions.
2. Assemble the new severe service fastener through the top pad and longitudinal torque rod. Tighten the locknut to \mathbb{N} 400 ± 25 foot pounds. See Figure 2.
