H ASSEMBLY INSTRUCTIONS

PRIMAAX®

SUBJECT: Severe Service Kit No. 60632-015

LIT NO: 59310-037

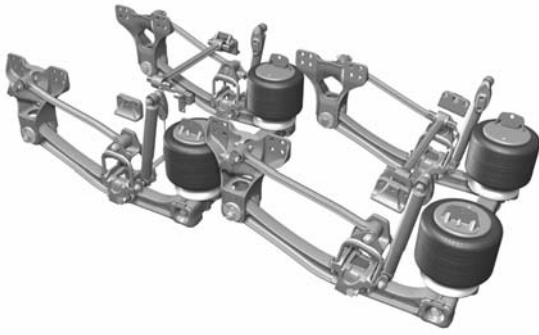
SEVERE SERVICE QUIK-ALIGN PIVOT BOLT AXLE KIT NO. 60632-015

PART NO.	DESCRIPTION	QTY.
67035-000	QUIK-ALIGN Concentric Base	2
67034-000	QUIK-ALIGN Eccentric Base	2
18500-003	1 1/4"-12 UNF Bolt - 8.0"	2
22962-019	1 1/4" Hardened Washer	4
67635-000	1 1/4"-12 UNF Locknut	2

SEVERE SERVICE QUIK-ALIGN PIVOT BOLT KIT
