# **TECHNICAL PROCEDURE**

## **ULTIMAAX® Severe-duty Rear Rubber Suspension System for Kenworth • Peterbilt Vehicles**

**SUBJECT:** Service Instructions

**LIT NO:** 17730-301

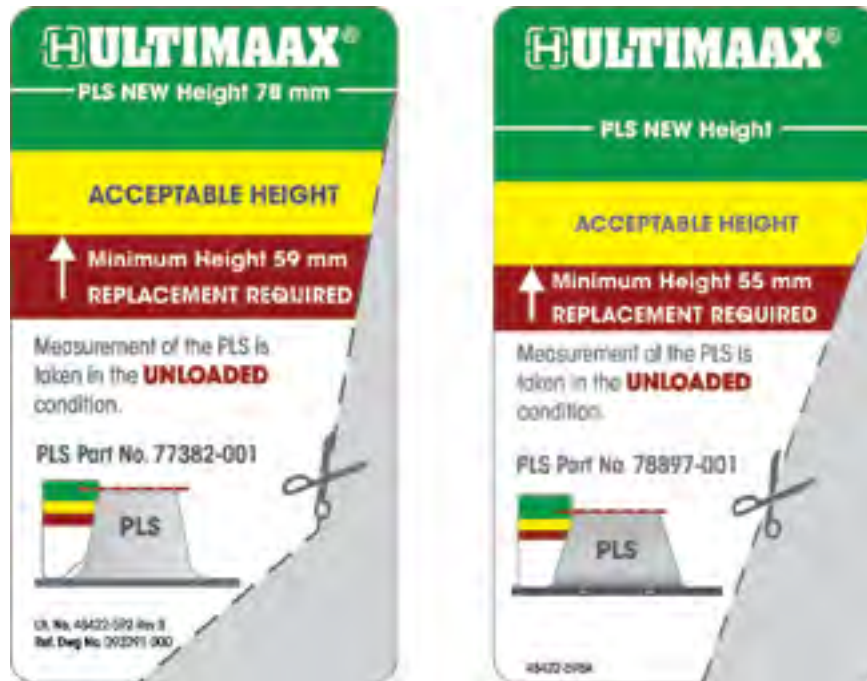
FIGURE 6-16

Use **Hendrickson gauge card (Lit. No. 48422-592 for 48K•52K) or (Lit. No. 48422-598 for 60K•70K)** in unloaded condition to help determine the height, length of cut or split and depth of separation of the ULTIMAAX progressive load spring (PLS), see Figure 6-16. These gauge cards are available on-line at [www.hendrickson-intl.com/Litform](http://www.hendrickson-intl.com/Litform)

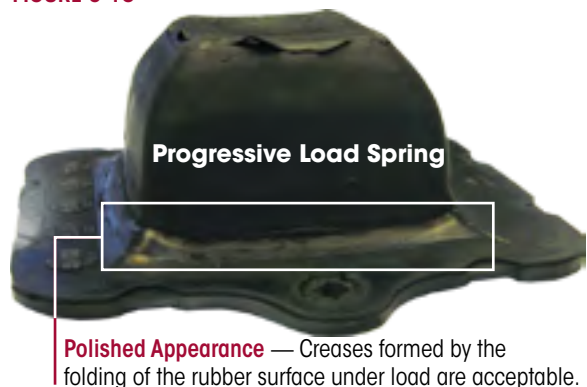
FIGURE 6-18

- A bent or cracked mounting base requires PLS replacement.
- If any cuts or splits in the rubber of over 2" (50 mm) in length and an average depth of ½" (13 mm), the effected PLS requires replacement. A certain amount of gradual breakup of the rubber surface is normal. The most probable areas for potential cuts, splits, or wear are shown in Figure 6-17 as "/////."
- Bonding separation of the rubber from the bonded rate plate surface to a maximum depth of approximately ½" (13 mm) is acceptable, see Figure 6-17. If the bonding separation depth is ½" (13 mm) or more, the effected PLS requires replacement.
- Creases formed by folding of the rubber surface under load are acceptable. These appear as stripes on the surface, polished by wear or covered with tacky rubber, see Figure 6-18.

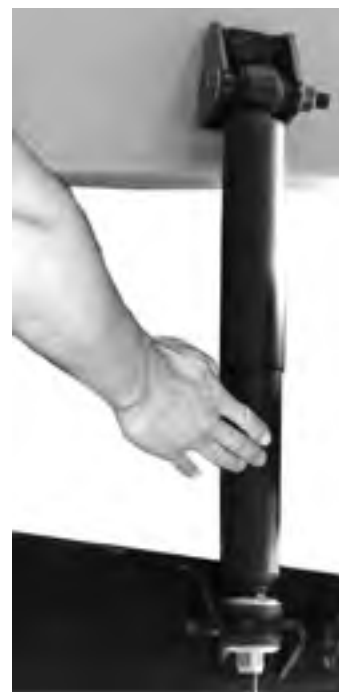
**FIGURE 6-25**

2. Use an infrared thermometer to check the temperature of the shock absorber. This can also be performed by carefully touching the shock absorber body below the dust cover. Touch the frame to get an ambient reference, see Figure 6-25. A warm shock absorber is acceptable, a cold shock absorber should be replaced.

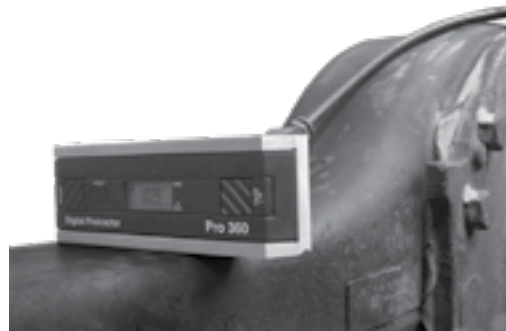
1. Use a work bay with a level floor.
2. Relax the suspension by slowly moving the vehicle back and forth several times in a straight line without using the brakes. This will slacken or loosen the suspension as the vehicle is positioned. End with all wheels positioned straight ahead. Roll to a stop without the brakes being applied. **DO NOT** set the parking brake.
3. Chock the front wheels of the vehicle.
4. Place a digital protractor on the axle housing as shown in Figure 7-1.
5. Check to see if the pinion angle is correct per the vehicle manufacturer's specified range.
6. If necessary, add/remove shims at the longitudinal torque rod connections as required to achieve the proper pinion angle.
7. When the pinion angle is correct tighten all fasteners to the proper torque specifications per the vehicle manufacturer and recheck the pinion angles.
8. Remove wheel chocks.

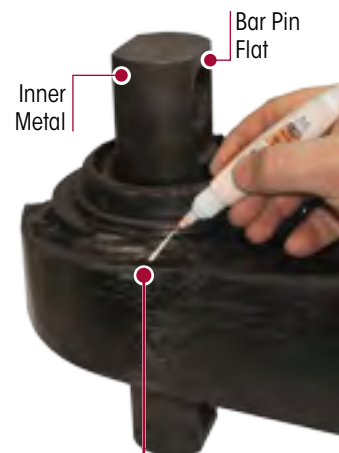
**FIGURE 8-30**

3. Prior to removal, mark the orientation of the bar pin flats on the equalizing beam with a paint stick, see Figure 8-30.
4. Support the beam end hub with it centered on the receiving tool. Be sure the equalizing beam is squarely supported on the press bed for safety.

5. Press on the end bushing inner metal, see Figure 8-30, of the end bushing until the inner metal is flush with the top of the equalizing beam end hub. This will move the bushing rubber away from the outer metal of the bushing so the removal tool (Part No. 66086-109) can be installed.

Mark the location of the bar pin flats with a paint stick on the equalizing beam end hub

1. The equalizing beam bore may have a more substantial lead in chamfer at one end of the bore than the other. Take advantage of the larger chamfer by pressing in the new end bushing from this end.
2. Lubricate the equalizing beam end hub inside bore and the bar pin end bushing outer sleeve with a NLGI #2 – EP (Extreme Pressure) grease.
3. Place the equalizing beam in a shop press with the end hub, squarely supported on the receiving tool, see Figure 8-32.
4. Position and align the end bushing to the mark made before removal as shown in Figure 8-30.

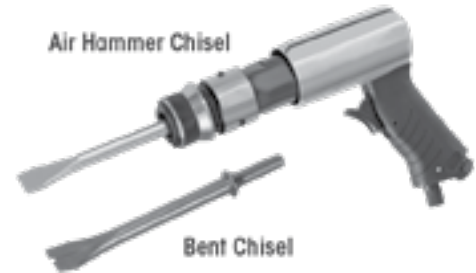
FIGURE 8-35

- A shop press with a capacity of at least 100 tons
- Air hammer / chisel / Bent chisel, see Figure 8-35
- OTC Part No. 1763, see Special Tools section of this publication

3. Locate the recess for the chisel, rotate the adapter if necessary. Place the air hammer/chisel in the recess.
4. If the adapter does not turn, use a hammer to rap the outside of the axle bracket legs around the adapter area and repeat with the air hammer chisel.
5. Support the end of the equalizing beam as it may drop when the other adapter is removed.
6. Remove remaining adapters.
7. When the adapter has enough clearance between the axle bracket and the adapter flange, use a bent chisel as shown in Figure 8-35 to wedge and force the adapter out.

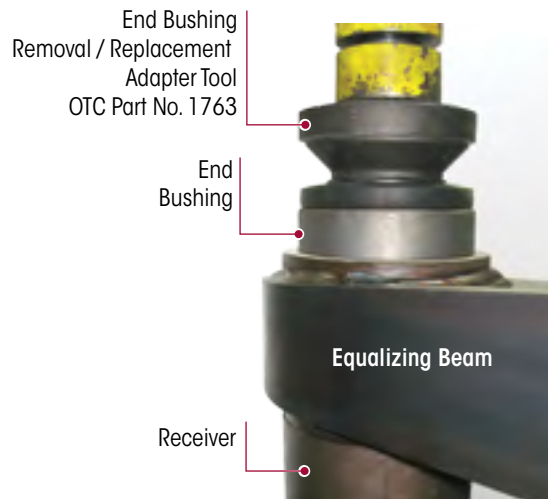
**FIGURE 8-38**

8. Remove the equalizing beam assembly from vehicle as detailed in the Equalizing Beam Disassembly instructions in this section.
9. Position the equalizing beam in the shop press and align the End Bushing Removal / Replacement Adapter with the tapered end facing the bushing to be removed, see Figure 8-38.
