# **H** TECHNICAL PROCEDURE

## OPTIMAAX® Liftable Forward Tandem Axle and Suspension System for Freightliner Cascadia Vehicles

SUBJECT: Service Instructions  
 LIT NO: 17730-309  
 DATE: March 2024

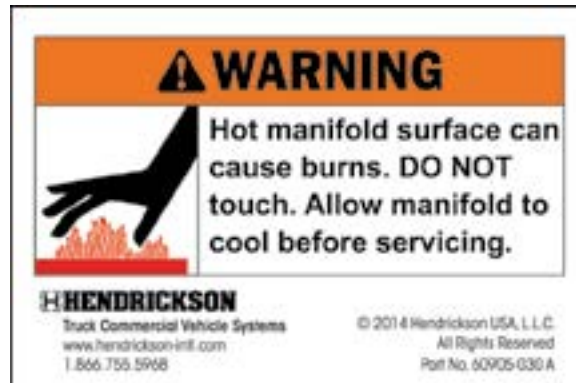
**FIGURE 3-2**

HOT AIR CONTROLLER MANIFOLD SURFACE CAN CAUSE BURNS. DO NOT TOUCH. ALLOW MANIFOLD TO COOL BEFORE SERVICING, SEE FIGURES 3-2 AND 3-3.

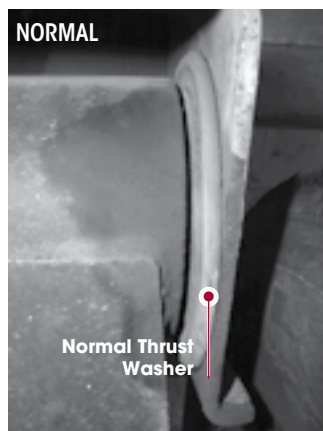
**FIGURE 6-10**

1. Visually inspect thrust washers. Due to the pivoting motion inherent with this connection, some thrust washer wear is expected, see Figure 6-10.
  - **Acceptable:** Cupping is an acceptable condition where the thrust washer forms around the axle beam assembly end hub and resembles a shallow dish, see Figure 6-11.
  - **Unacceptable:** A missing, cut, worn-through or deteriorated thrust washer requires replacement, see Figure 6-12. Refer to the Component Replacement section of this publication.

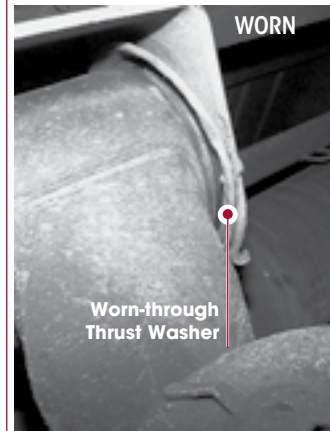
**FIGURE 6-12**  
**UNACCEPTABLE**

**Worn Thrust Washer**  
The thrust washer shows extreme wear. The thrust washer circumference is completely trimmed by the axle beam assembly end hub. Replacement required.

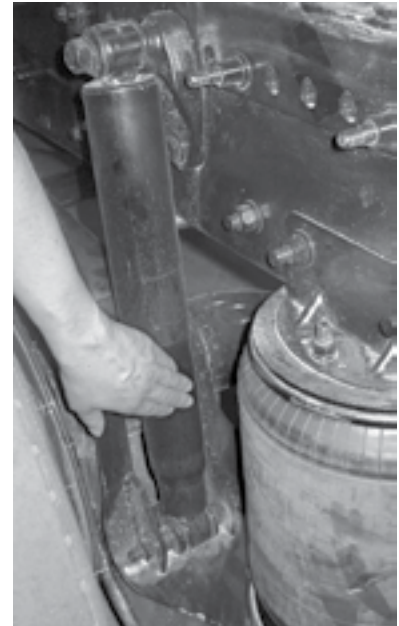
FIGURE 6-13

a. Perform a heat test by carefully touching or placing a hand near the shock absorber body below the dust cover. Touch the frame to get an ambient reference, see Figure 6-13. A shock absorber that is warm to the touch is acceptable, a cold shock absorber should be replaced.

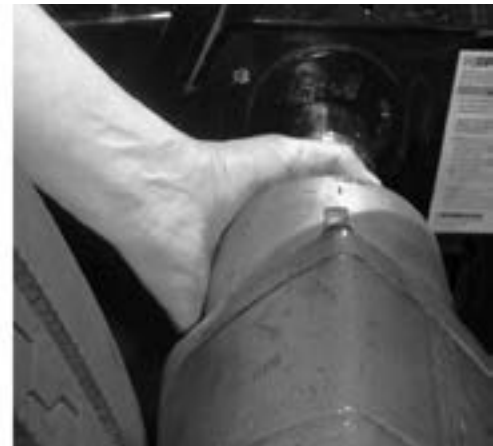
FIGURE 7-8

8. Repeat Steps 2 through 7 on the opposite QUIK-ALIGN connection if necessary, to accurately complete the alignment of the liftable forward tandem axle.
9. Snug the QUIK-ALIGN fasteners and recheck alignment, see Figure 7-8.

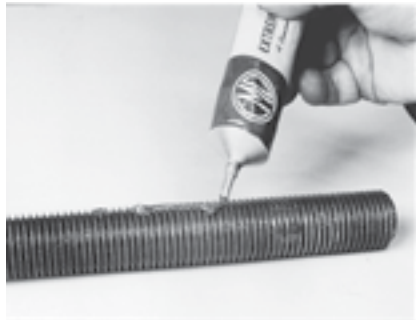
FIGURE 8-8

- Threads of the hex-head bolt, see Figure 8-8.
- Internal parts of the thrust bearing and external surfaces of the tool thrust washers, see Figures 8-9 and 8-10.

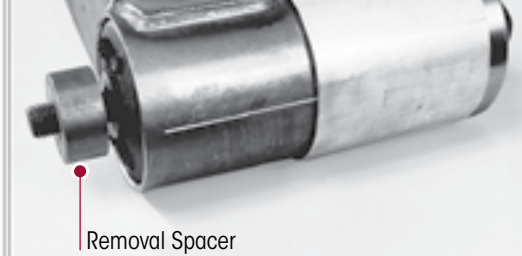
**FIGURE 8-13**

20. Slide the removal spacer over the exposed hex-head bolt threads on the opposite side of the axle beam assembly end hub, see Figure 8-13.

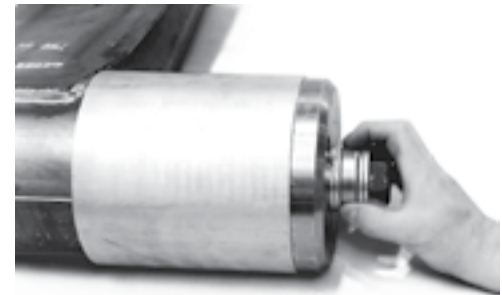
**FIGURE 8-15**

The tool thrust bearing needs to be free to turn to prevent binding or damage to the threads of the hex-head bolt during the removal process, see Figure 8-15.

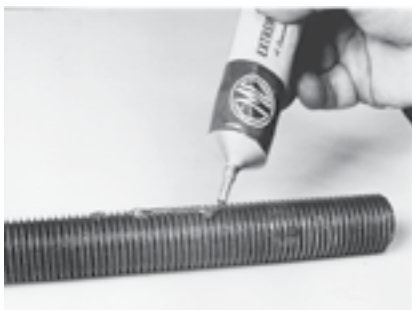
**FIGURE 8-20**

6. Apply extreme-pressure lube (provided with TRI-FUNCTIONAL III Bushing Tool) to the:
  - Tool threads of the hex-head bolt, see Figure 8-20.
  - Internal parts of the tool thrust bearing and external surfaces of the tool thrust washers, see Figures 8-21 and 8-22.

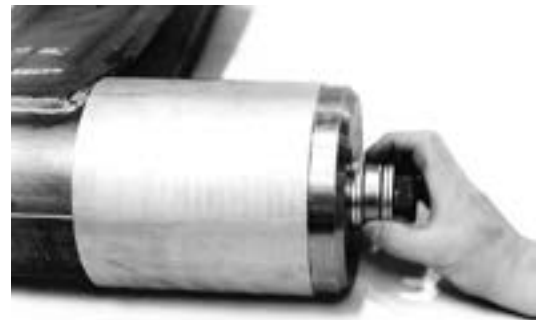
**FIGURE 8-27**

13. Push the tool parts together, making sure the front plate is squarely seated on one side of the axle beam assembly end hub and the transition tube is squarely seated on the other side, see Figure 8-27. Hand tighten the hex-head bolt.

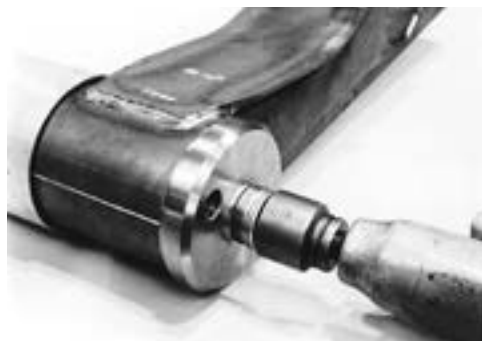
**FIGURE 8-28**

18. Use a 3/4" impact wrench and a 1<sup>1</sup>/<sub>16</sub>" heavy-duty (six-point) impact socket, install the bushing by turning the hex-head bolt clockwise, see Figure 8-28. When the bushing is approximately halfway in the axle beam assembly end hub, the impact wrench may slow down. After a very short time, the wrench will pick up speed again.
